Re: *Dredge Spoil Area Evaluation Report*  
Solutia Inc. Anniston, AL Facility  
EPA ID No. ALD 004 019 048

**DREDGE SPOIL AREA EVALUATION REPORT  
SNOW CREEK AND CHOCCOLOCCO CREEK  
CALHOUN AND TALLADEGA COUNTIES, ALABAMA**

**ROUX ASSOCIATES, INC.  
1110 Nasa Road One, Suite 207  
Houston, Texas 77058  
(281) 335-4000**

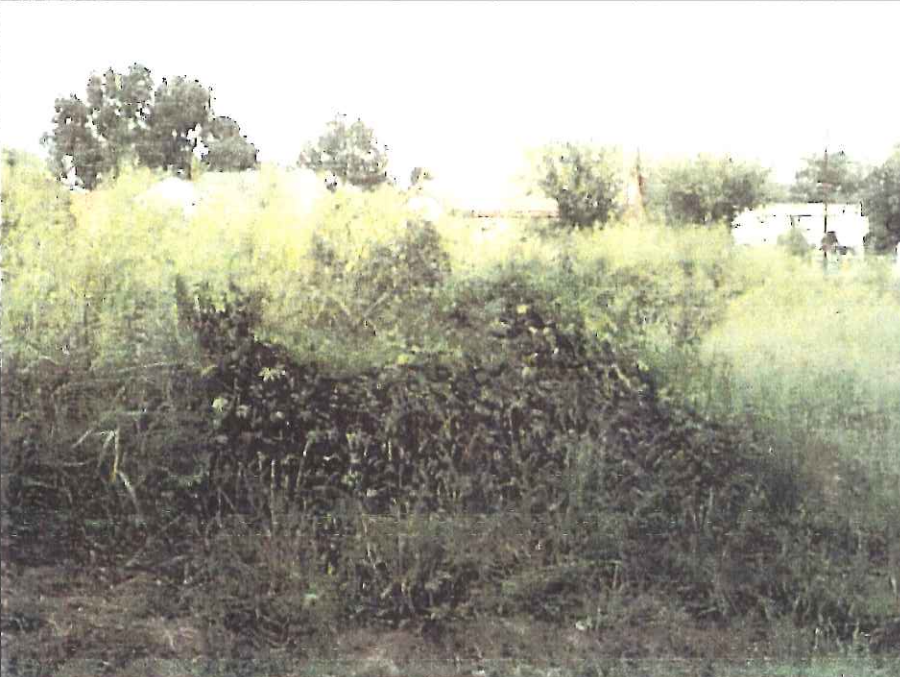
| | uneven,<br>1 : 1 | 4 | uneven,<br>1 : 1 | 4 | Portions<br>near vertical | Some minor slumping | |
| <b>SIDE VIEW</b> | | | <b>Photo Caption:</b> Area 6, view to the east. | | | | |

Dredge spoil Area Nos. 3 through 6 extend to the Creek bank and exhibit average slopes of 1:1 (H:V). Vegetation is well established at each area; however, each area exhibits some evidence of minor slumping. In order to prevent further slumping of these areas, it is recommended that permanent turf reinforcement mats be installed and seeded. Preparation of these areas will require the removal of large rocks, soil clods and existing vegetation to ground level to ensure intimate contact between the mats and subgrade. A turf reinforcement mat would then be installed, and the areas would be hydro-seeded to establish a good stand of grass. The turf reinforcement mats will stimulate rapid vegetative growth and provide permanent resistance to elevated hydraulic forces. The mats will permanently anchor the vegetative cover to the soil surface and provide twice the erosion protection of unreinforced vegetation. Typical specifications for turf reinforcement mats are provided in Appendix B. The mats are composed of a dense, three-dimensional web of polypropylene fibers, placed between two high strength nets and stitched together. The mats are installed in overlapping rolls and secured with ground-anchoring devices.

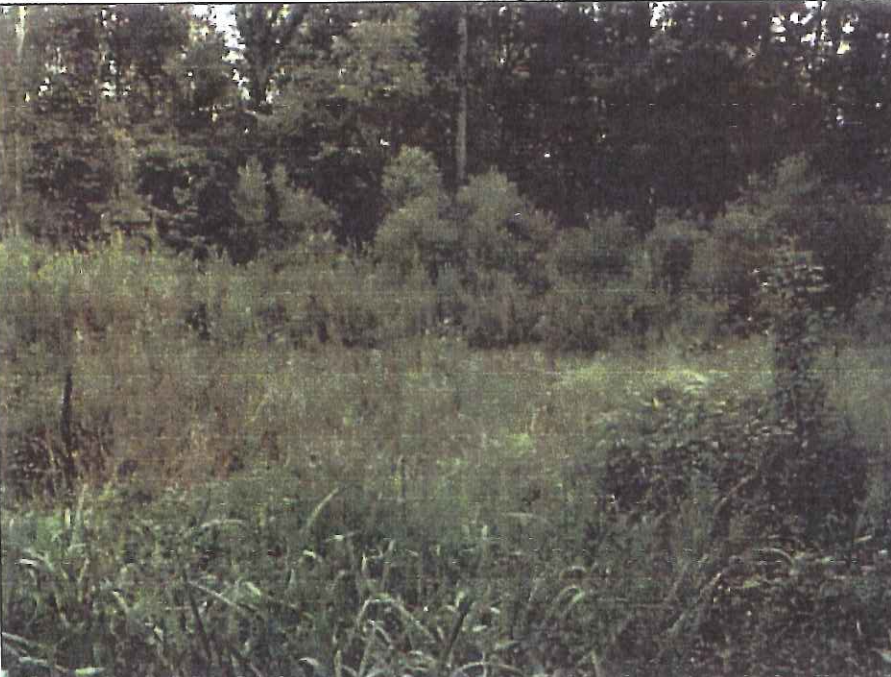
| | Flat | -NA- | Flat | -NA- | Flat | No | |
| Photo Caption: Area 1, view to the west. | | | | | | | |

area. Area No. 1 is covered with a non-woven geotextile material; however, weeds are growing through at the geotextile overlaps (Appendix A). For this area, it is recommended that the existing cover material be removed and replaced with vegetative cover. Preparation of this area will require the removal and disposal of the existing fabric material and subsequent mowing of weeds to ground level. The area would then be hydro-seeded to establish a good stand of grass.
