*Screening Level Ecological Risk  
Assessment (SLERA)  
for Operable Units 1, 2, and 3  
of the Anniston PCB Site*

**Anniston PCB Site  
Anniston, Alabama**

**Revision 1  
December 2005**

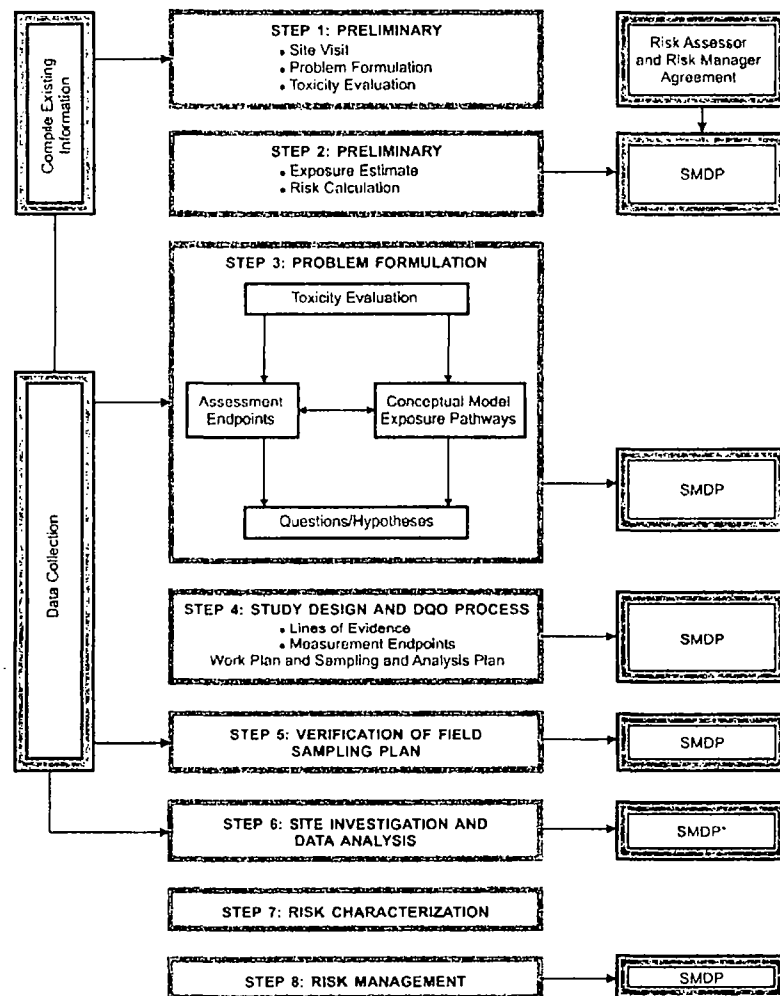
### USEPA's Eight-Step Process for Conducting Ecological Risk Assessments

This report was developed in accordance with the CD and the eight-step process described by the USEPA in the *Ecological Risk Assessment Guidance for Superfund: Process for Designing and Conducting Ecological Risk Assessment* (see figure on next page, adapted from USEPA, 1997a) and follows the recommendations of the USEPA's supplemental guidance document, *Amended Guidance on Ecological Risk Assessment at Military Bases: Process Considerations, Timing of Activities, and Inclusion of Stakeholders* (USEPA, 2000). The methodology developed by the USEPA provides a rational, science-based approach for evaluating ecological risks for remedial decision making and the Site administrative record. This report describes the completion of the screening level portion of the ecological risk assessment process using readily available exposure media data (Steps 1 and 2 of the ecological risk assessment process).

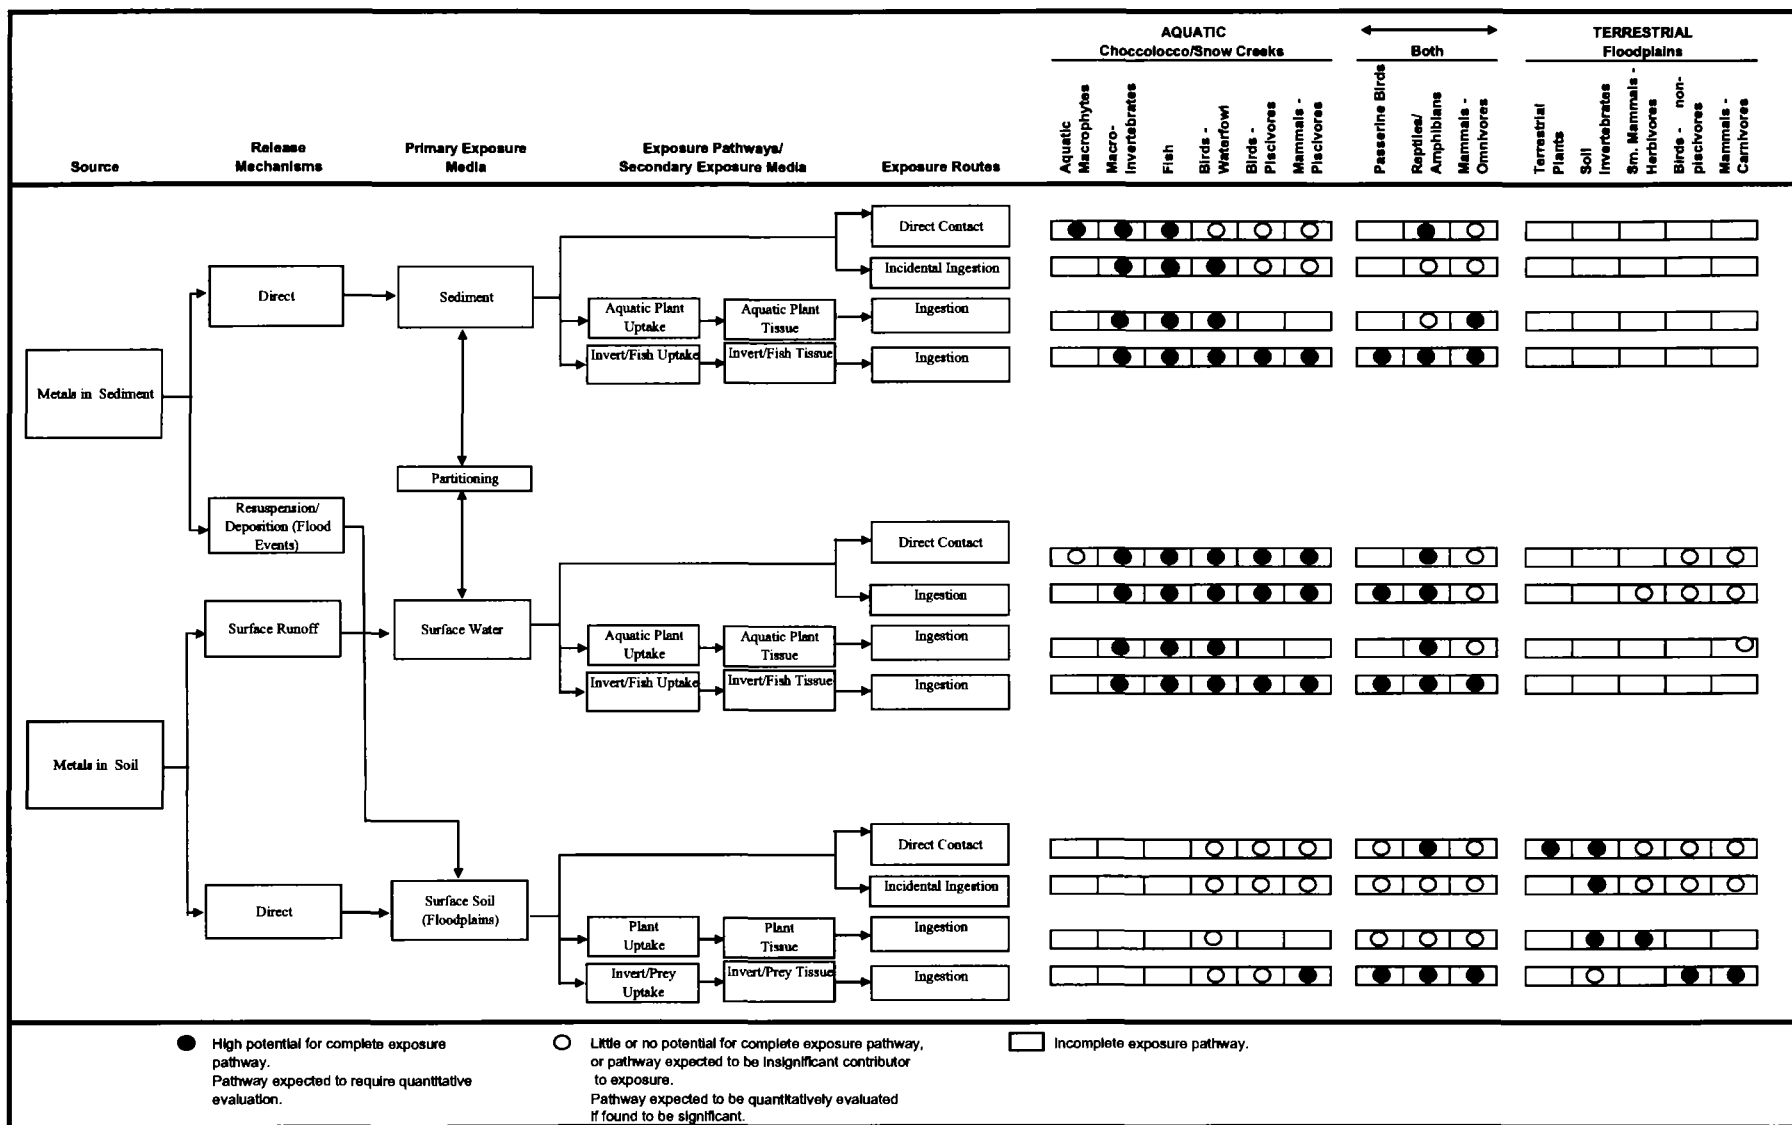
FIGURE  
4

**CONCEPTUAL EXPOSURE MODEL FOR  
ECOLOGICAL RECEPTORS: METALS**

direct uptake. Also, unlike PCBs, metals can sorb and desorb from soil and sediment with equal ease, depending on the physical and chemical conditions at a particular site or moment in time. Furthermore, although most metals may be absorbed into plant or animal tissues, they generally do not biomagnify in higher trophic levels. Using these general observations, the conclusions described below can be made about the complete pathways for ecological receptors in OUs 1, 2, and 3 that are potentially exposed to metals.

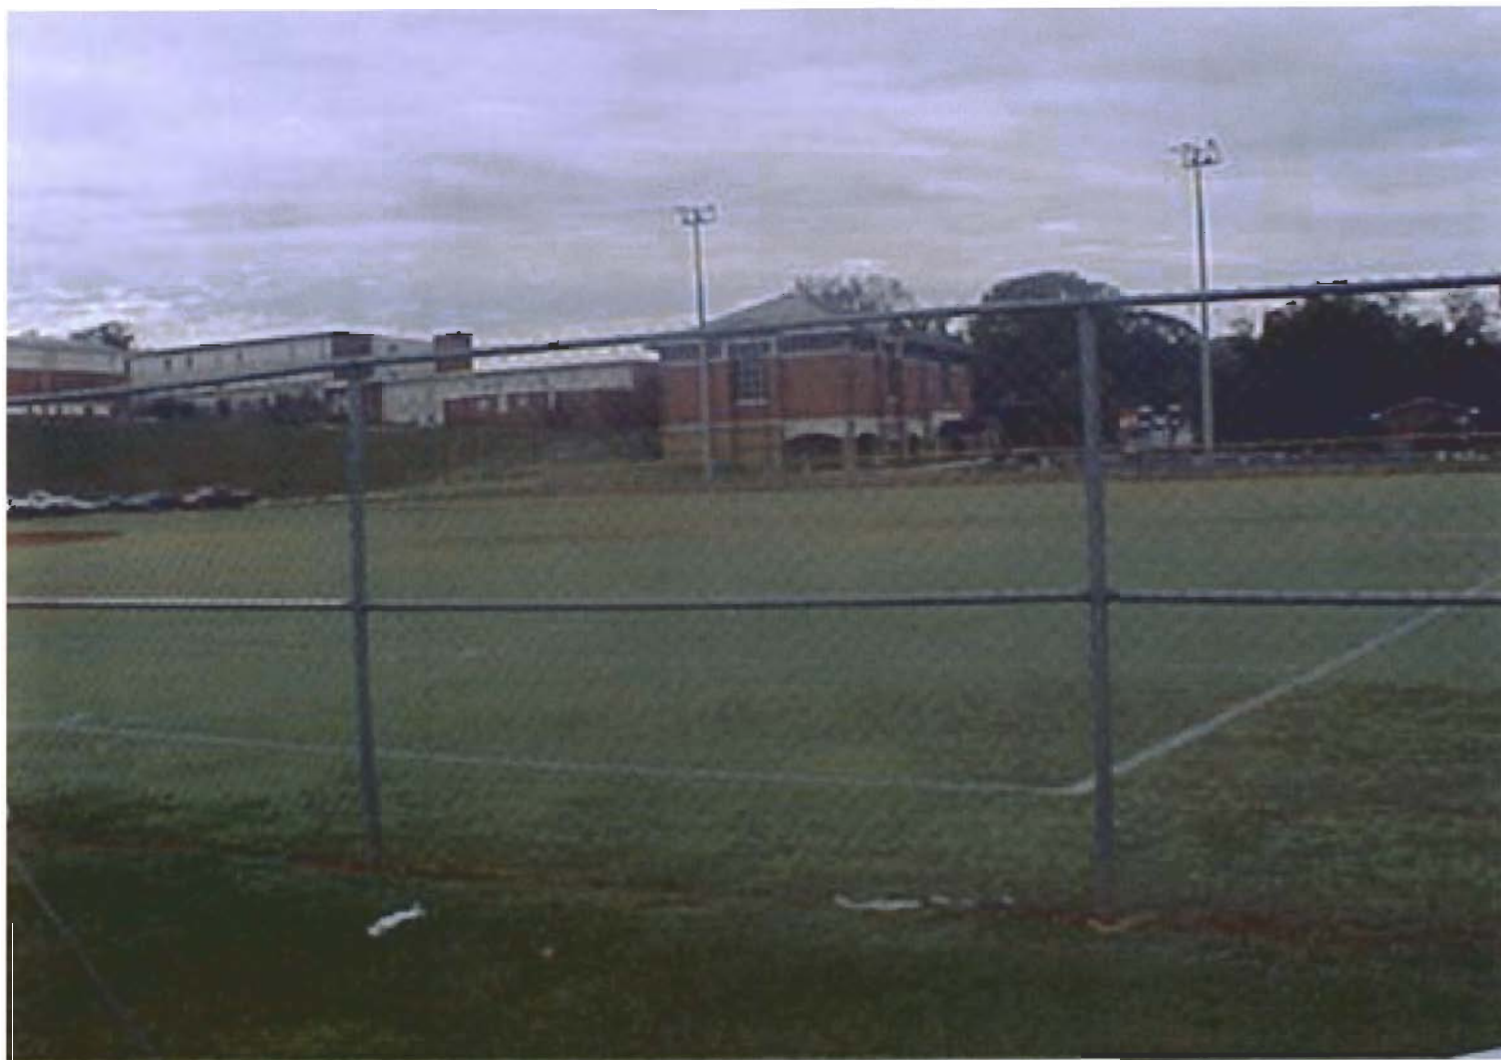
**FIGURE  
20**

**RECREATION/SCHOOL LAND USE SHOWING  
LARGE MANICURED FIELD FOR SPORTS**

**Recreational/School.** Land use in these areas is dominated by playgrounds, ball fields, and large areas of maintained and manicured lawns (nearly 100% cover) (Figures 20 and 21). Functional ecological habitats are confined to less regularly maintained fields where songbirds typical of urban environments were observed foraging.
