Re: *Dredge Spoil Area Evaluation Report*  
Solutia Inc. Anniston, AL Facility  
EPA ID No. ALD 004 019 048

**DREDGE SPOIL AREA EVALUATION REPORT  
SNOW CREEK AND CHOCCOLOCCO CREEK  
CALHOUN AND TALLADEGA COUNTIES, ALABAMA**

**ROUX ASSOCIATES, INC.  
1110 Nasa Road One, Suite 207  
Houston, Texas 77058  
(281) 335-4000**

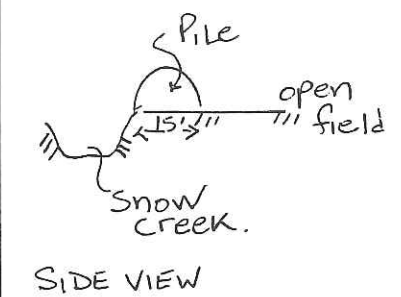
Dredge spoil Area Nos. 3 through 6 extend to the Creek bank and exhibit average slopes of 1:1 (H:V). Vegetation is well established at each area; however, each area exhibits some evidence of minor slumping. In order to prevent further slumping of these areas, it is recommended that permanent turf reinforcement mats be installed and seeded. Preparation of these areas will require the removal of large rocks, soil clods and existing vegetation to ground level to ensure intimate contact between the mats and subgrade. A turf reinforcement mat would then be installed, and the areas would be hydro-seeded to establish a good stand of grass. The turf reinforcement mats will stimulate rapid vegetative growth and provide permanent resistance to elevated hydraulic forces. The mats will permanently anchor the vegetative cover to the soil surface and provide twice the erosion protection of unreinforced vegetation. Typical specifications for turf reinforcement mats are provided in Appendix B. The mats are composed of a dense, three-dimensional web of polypropylene fibers, placed between two high strength nets and stitched together. The mats are installed in overlapping rolls and secured with ground-anchoring devices.

| | uneven,<br>1 : 1 | 4 | uneven,<br>1 : 1 | 4 | Portions<br>near vertical | Some minor slumping | |
| <b>SIDE VIEW</b> | | | <b>Photo Caption:</b> Area 6, view to the east. | | | | |
